MAG-SHIELDS® prevent additional damage by capturing contaminants following torque converter failure in a CAT 777 haul truck

A CAT 777D operating at a northern Alberta oil sands mine suffered a torque converter failure. This failure can be particularly catastrophic because the torque converter, braking and hoisting systems share the same hydraulic oil. When a torque converter failure occurs, a significant amount of metal contamination is released into the system and quickly circulated through all the circuits. The entire contents of the hydraulic system (405L or 107 US gallons) can circulate in approximately 1 minute, so contamination spreads quickly causing damage and accelerated wear to the brake and hoist components.

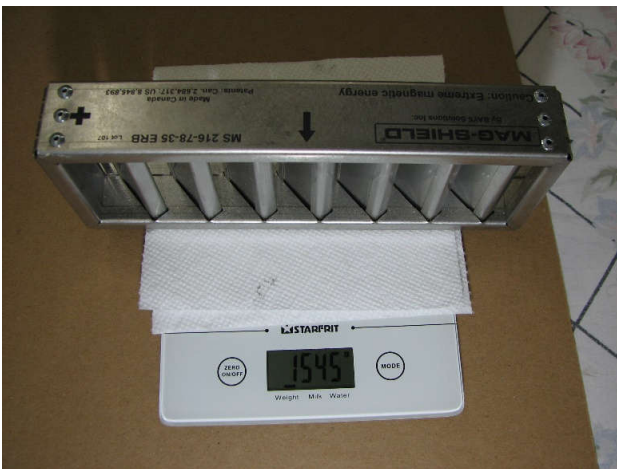
A new Mag-Shield weighs 1.545 kg.

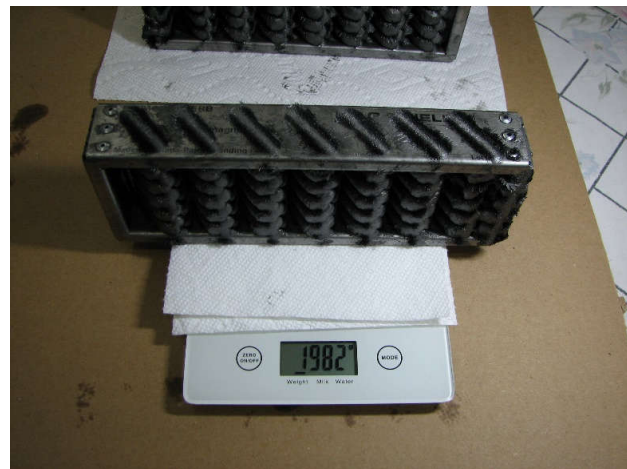
One of four Mag-Shields recovered following the torque converter failure, indicating that 437 grams of material was captured.

Following the failure the hydraulic tank was drained, and all 4 Mag-Shields were removed and weighed before cleaning and analysis. It was determined that 1.717kg (3.78 lbs) of material was captured by Mag-Shields which would have otherwise flowed throughout the system and caused additional damage. Mag-Shields made cleaning the hydraulic system faster and more effective. Post failure clean up is made possible as Mag-Shields continue to clean residual contaminants from the system when the truck is put back into service. Follow-on failures were mitigated, and significant savings were observed by the truck owner.

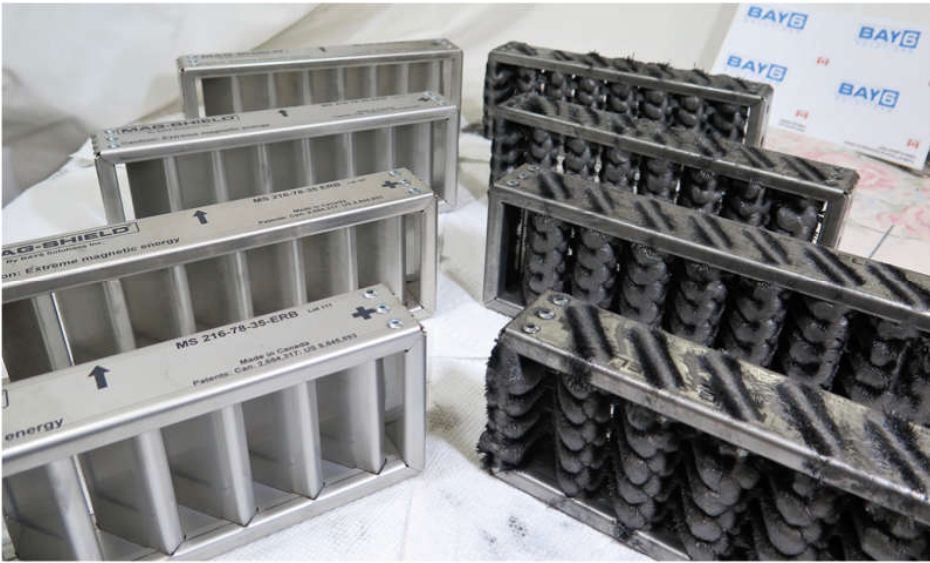
Side-by-side comparison of new Mag-Shields to those that were removed from the CAT 777D post torque converter failure. All the particles on the dirty Mag-Shields were prevented from continuously circulating through the system.

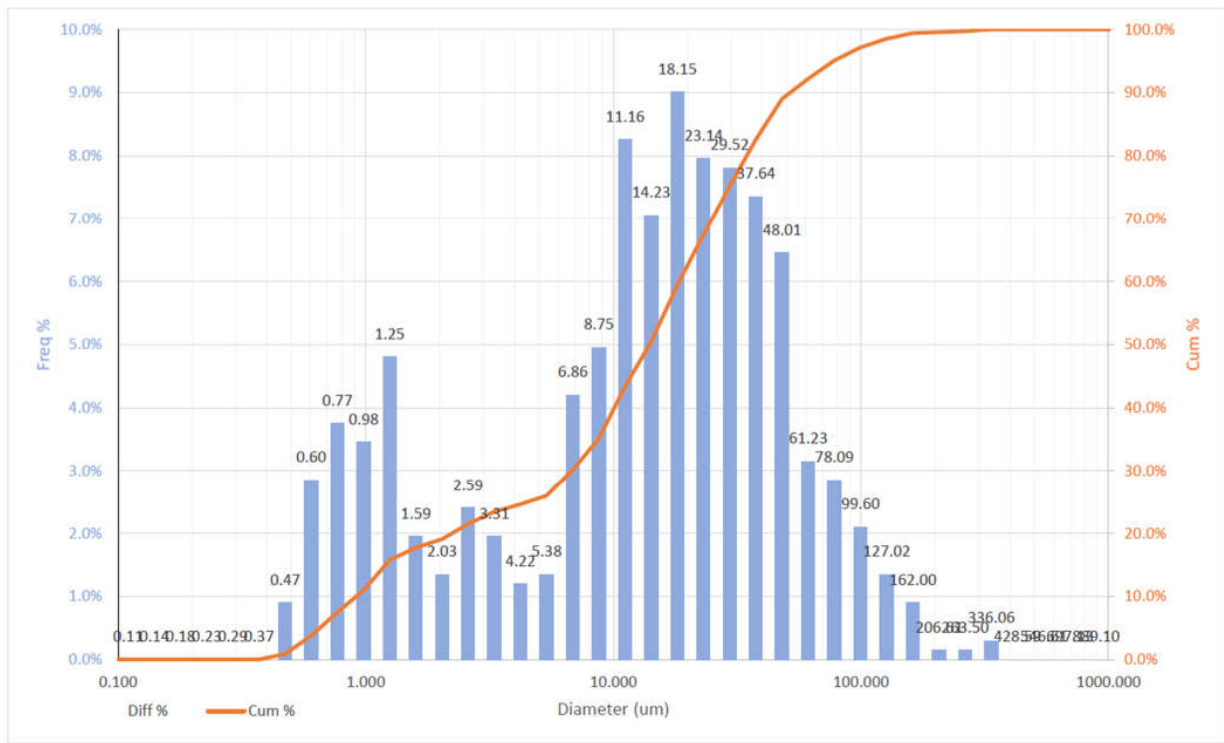
Particle Size Graph

Additionally, a sample from the dirty Mag-Shields was submitted to SEMx Inc. for scanning electron microscopy analysis which determined a captured particle distribution of: approximately 57% were between 5µm and 40µm (these may not be captured by CAT Regular Efficiency filters), and approximately 26% of the captured particles were under 5µm (these particles may not be captured by CAT Ultra High Efficiency filters). Unlike OEM filters, Mag-Shields were able to capture and hold these ferrous particles, stopping them from circulating further throughout the system. OEM filters were not effective at removing smaller sizes of particles or simply plug up with large volumes or contamination, forcing the system into bypass operation.
