MAG-SHIELDS® Reduce Repeat Failures and Fluid Contamination Alarms in Hitachi EX5600 Excavator

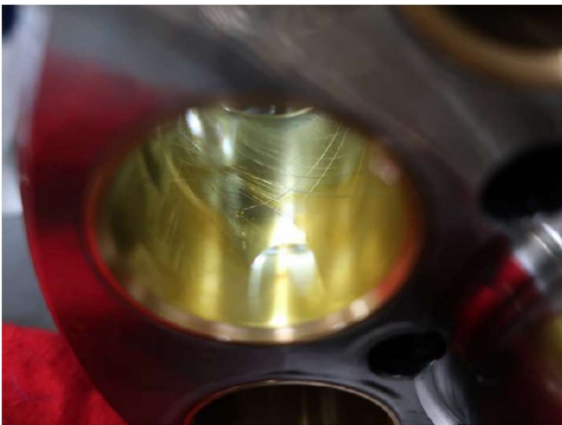
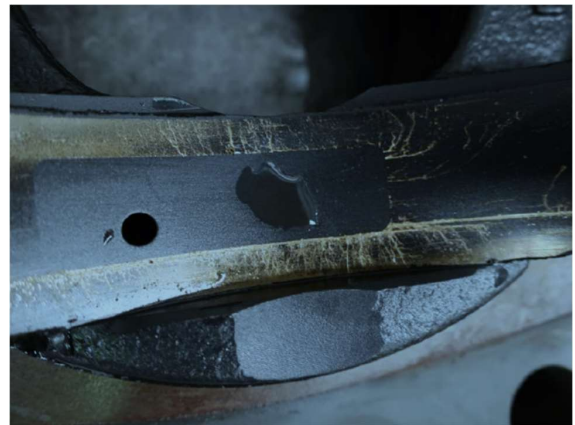
A fleet of excavators operated at an Australian mine were suffering long term successive failures of the hydraulic main pumps. Teardown of the damaged pumps indicated that contaminated fluid was entering the pumps from the suction side and causing damage. Additionally, false contamination sensor alarms were instigating the replacement of components up to 75% short of the component's estimated life.

Scoring present on main pump components caused by contaminated hydraulic fluid, prior to Mag-Shield Installation

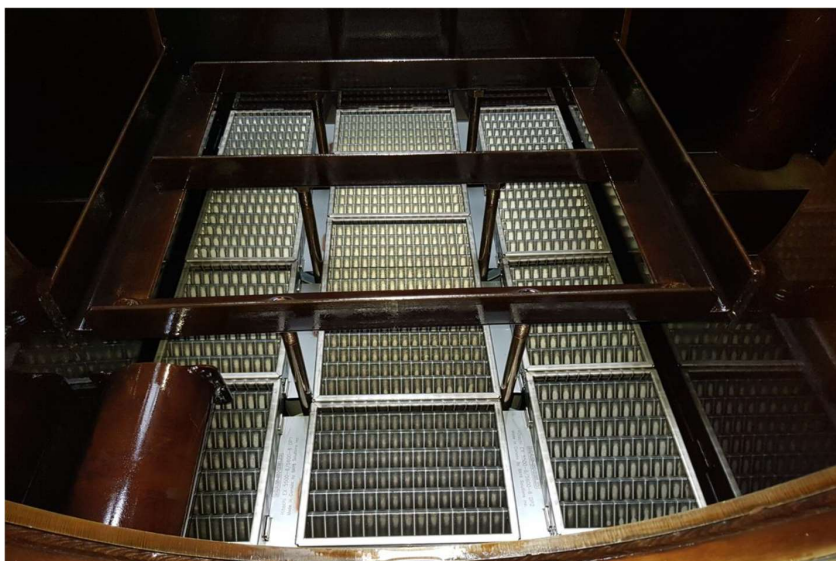
BAY6 Solutions Mag-Shield filtration system installed in the main hydraulic tank of a Hitachi EX5600 excavator.

The fleet operator reached out to BAY6 Solutions to provide a Mag-Shield magnetic filter solution for their fleet. The customer installed Mag-Shields on one of several problematic excavators that was experiencing numerous repeat failures. Contamination returning to the hydraulic tank from any component failure is immediately captured and held by Mag-Shields preventing the spread throughout the system. Following repairs, residual contamination is captured and prevented from recirculating.

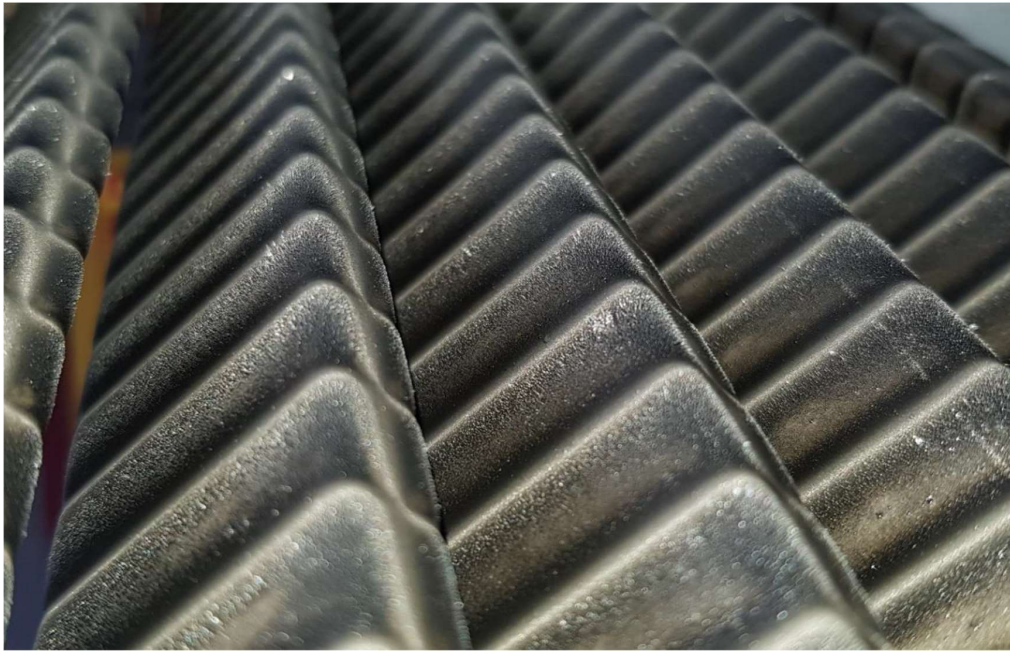
Following installation of the Mag-Shields, the frequency of contamination sensor alarms and contamination sensors requiring physical cleaning has been reduced by 75%. Engineering at the trial site reported the following: “Oil analysis results were inconclusive. As shown by the image (below) there was a consistent covering of extremely fine particles on all surfaces, there was also a significant build up on the edges of the screens in the lower flow areas. It also shows that particles of the size caught by Mag-Shields are not accurately reflected in oil sample reports.”

Mag-Shield from hydraulic tank of EX5600 with long-term contamination problems.
