## Brake Cooling Hydraulic Systems on CAT 994H Loader Guarded by MAG-SHIELDS®

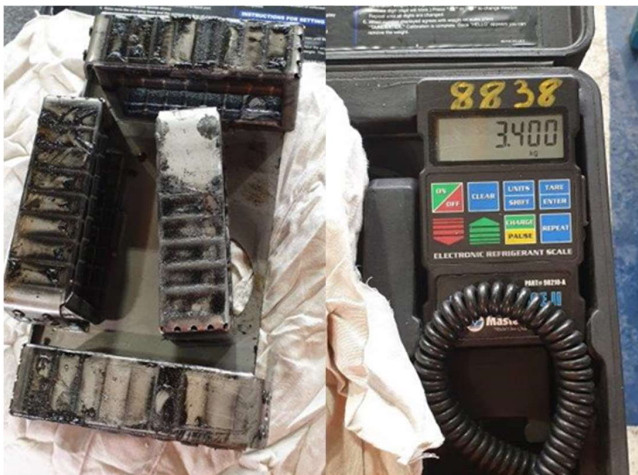
**MAG-SHIELDS® weigh  
3.4kg after 5154 hours of  
normal operation.**

These images represent Mag-Shield performance over a period of 5000 hours, in a 994H loader operating at an Australian mine site. During this timeframe, there were no failures within the brake cooling circuit. Over the course of normal operation, 50 grams of ferrous material was collected by the Mag-Shields. Capturing the material that is produced during normal operation is key to improving oil cleanliness and component life, which helps mitigate failures. The result: less disruption for operations, planning and maintenance; improved availability and significant savings.

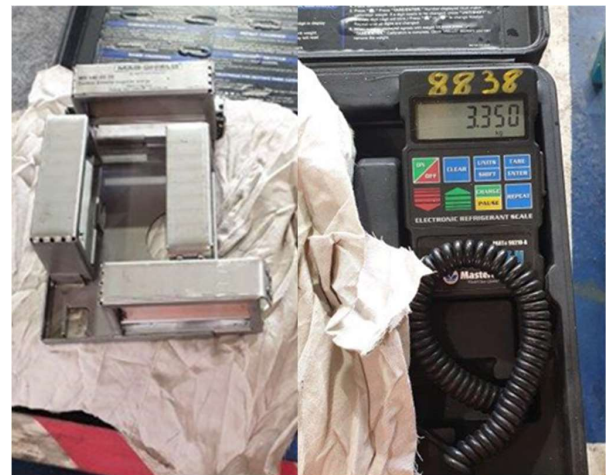
**Clean MAG-SHIELDS® weigh  
3.35kg.**
