MAG-SHIELDS® Protect the Hydraulic Systems of a CAT 994H Loader

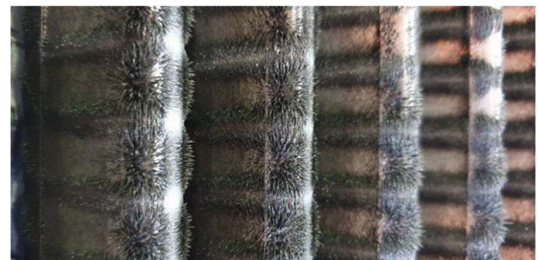
Ferrous material from normal operation trapped on a Mag-Shield® in the hydraulic reservoir of a CAT 994H.

Installation of BAY6 Solutions' Mag-Shield magnetic filters provides additional filtration for the main hydraulic system and significantly reduces the costs and frequency of system failures. As contaminated hydraulic fluid returns to the hydraulic reservoir, ferrous material is captured by the Mag-Shields before it can spread to the rest of the system. Following repairs, residual contamination is captured and prevented from recirculating. Having the ability to filter ferrous contamination out of the oil results in much cleaner oil. This reduces component wear which results in increased component life and lower frequency of failures,

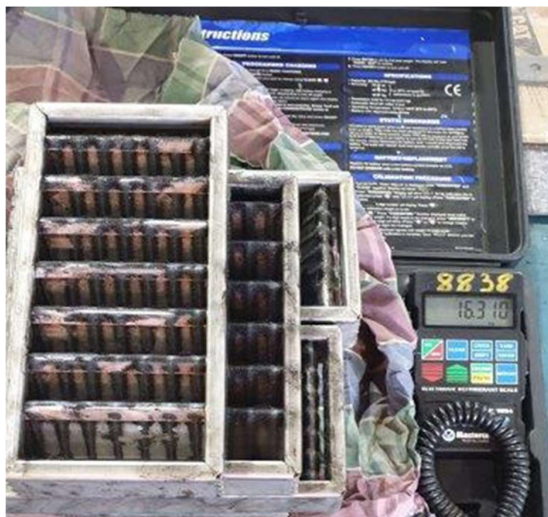
MAG-SHIELDS® weigh 16.31kg after 5180 hours of normal operation.

These images represent Mag-Shield performance over a period of 5000 hours, in a 994H loader operating at an Australian mine site. During this timeframe, there were no failures within the hydraulic system. Over the course of normal operation, 110 grams of ferrous material was collected by the Mag-Shields. Capturing the material that is produced during normal operation is key to improving oil cleanliness and component life, which helps mitigate failures. The result: less disruption for operations, planning and maintenance; improved availability and significant savings.

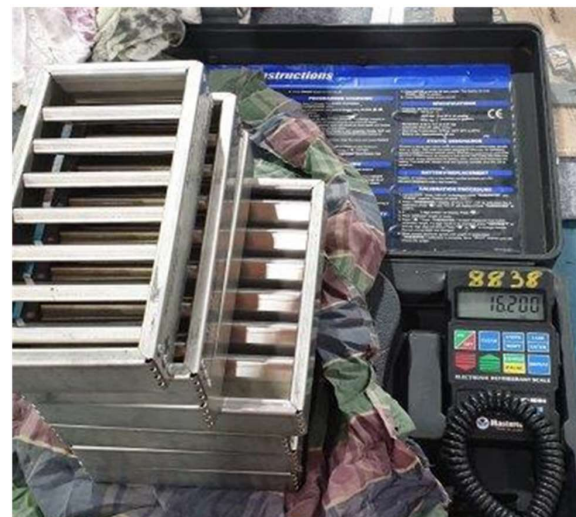
Clean MAG-SHIELDS® weigh 16.20kg.
